PROJECT: Staples, Norwich

Delvemade Protective Coatings Programme

Specification:

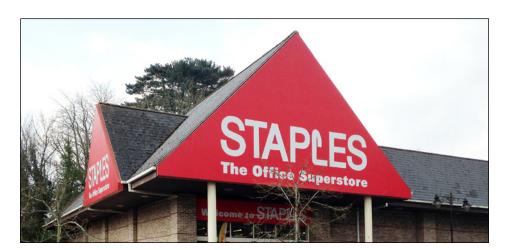
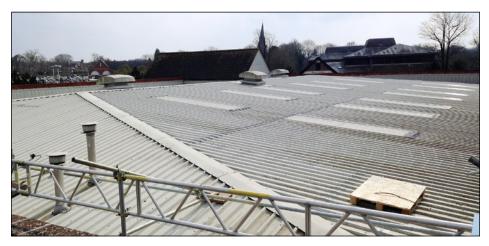
The problem was cut edge corrosion. It can be caused by a combination of poor installation techniques and on-site cutting plus attack from acid rain and pollutants, which are then retained as moisture in critical roof overlaps and gutter overhangs. This results in corrosion of the profiled steel roof sheets. If not treated quickly and effectively, the damage could lead to the need for partial or complete roof replacement.

SEAMSIL® for cut edge corrosion

DELCOTE® for roof recoating
