PROJECT : Total Fitness, Altrincham

Delvemade Protective Coatings Programme

Seamsil® has been specified and used to secure the long term performance of the roof at the Altrincham Total Fitness Centre with a roof makeover with Seamsil® the UK's leading Cut Edge Corrosion Treatment.

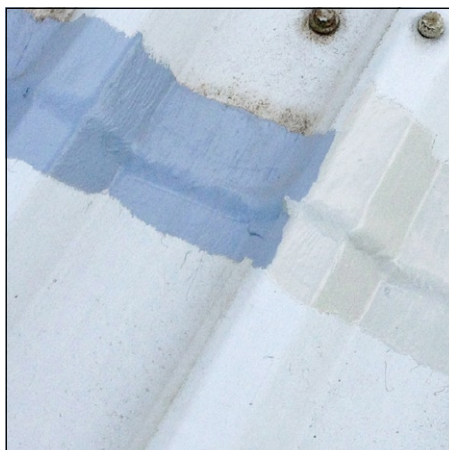
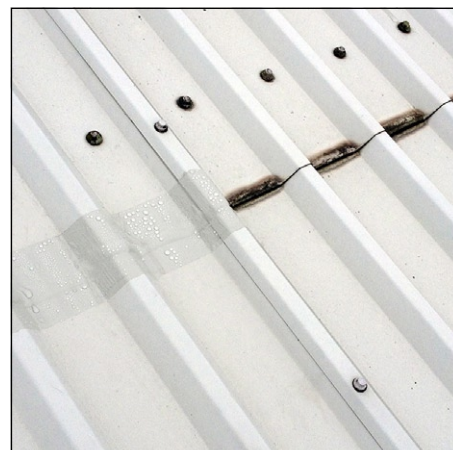
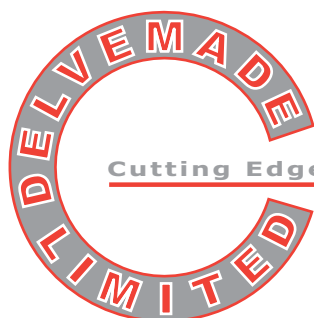
The problem was cut edge corrosion. It can be caused by a combination of poor installation techniques and on-site cutting plus attack from acid rain and pollutants, which are then retained as moisture in critical roof overlaps and gutter overhangs. This results in corrosion of the profiled steel roof sheets. If not treated quickly and effectively, the damage could lead to the need for partial or complete roof replacement.
