PROJECT : David Lloyd Racquet and Fitness Club, South Wales

Delvemade Protective Coatings Programme

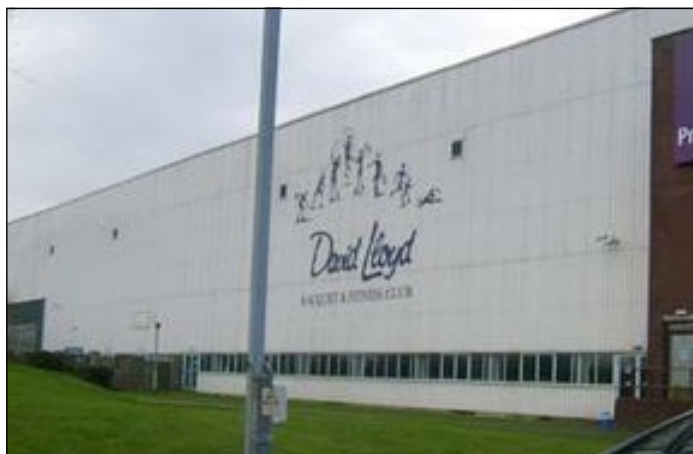
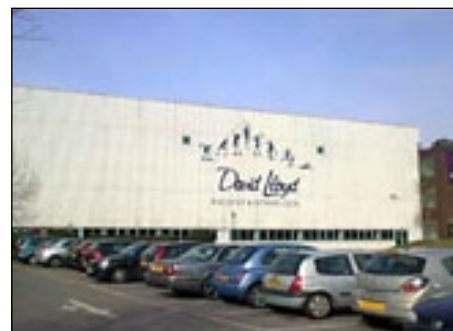
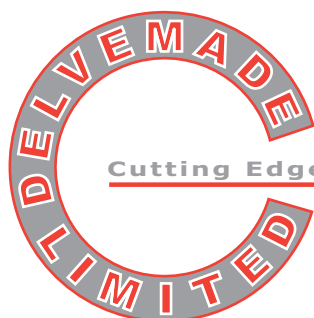
When faced with the problem of rust-affected peeling edges on the roof sheets of their fitness complex in Cardiff, David Lloyd turned to Seamsil®. Contractors Roofmaster of Bedford correctly diagnosed the underlying cause - classic sheet edge corrosion, which, once established, can wreak havoc with even the best of buildings - and then treated it with Seamsil® which has been used successfully for just such problems for over 15 years. Once again it proved to be the ideal solution to get this building's roofing back into shape.

SEAMSIL® for cut edge corrosion

DELCOTE® for roof recoating
