PROJECT : Asda, Pontefract

Delvemade Protective Coatings Programme

Pontefract site, is latest ASDA store to get Seamsil® cut edge roofing treatment.

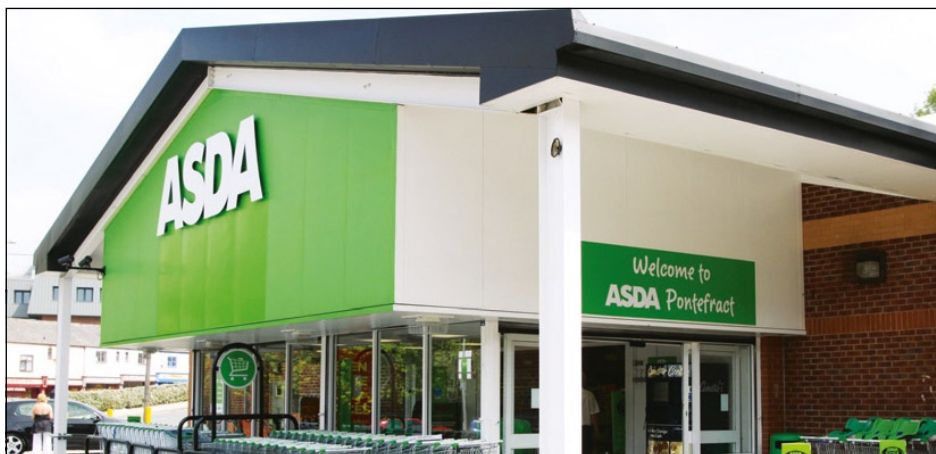
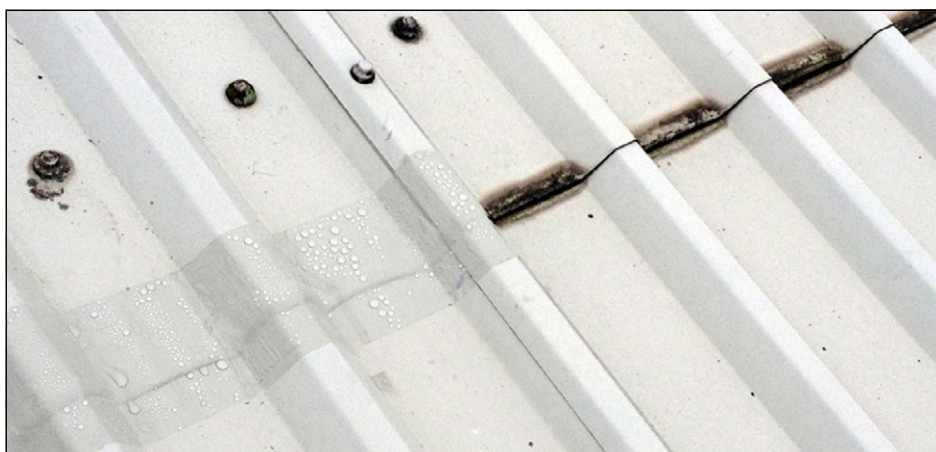
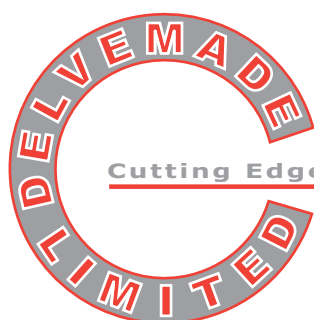
The problem was cut edge corrosion. It is caused by a combination of poor installation techniques and on-site cutting plus attack from acid rain and pollutants, which are then retained as moisture in critical roof overlaps and gutter overhangs. This results in corrosion of the profiled steel roof sheets. If not treated quickly and effectively, the damage can often lead to the need for partial or complete roof replacement. Seamsil® provides an ideal sustainable solution to the problems. It helps to extend the life of roofs treated and retain property value.

In 1994 ASDA had the foresight to use an innovative product called Seamsil®, to repair the roof of its Lutterworth Magna Park distribution centre. 20 years later its Pontefract store has become the 34th ASDA property to benefit from the patented silicone external repair system, for cut edge corrosion on profiled Plastisol/PVDF coated steel roof sheeting.
