# PROJECT : Asda, Pontefract

Delvemade Protective Coatings Programme

Pontefract site, is latest ASDA store to get Seamsil® cut edge roofing treatment.

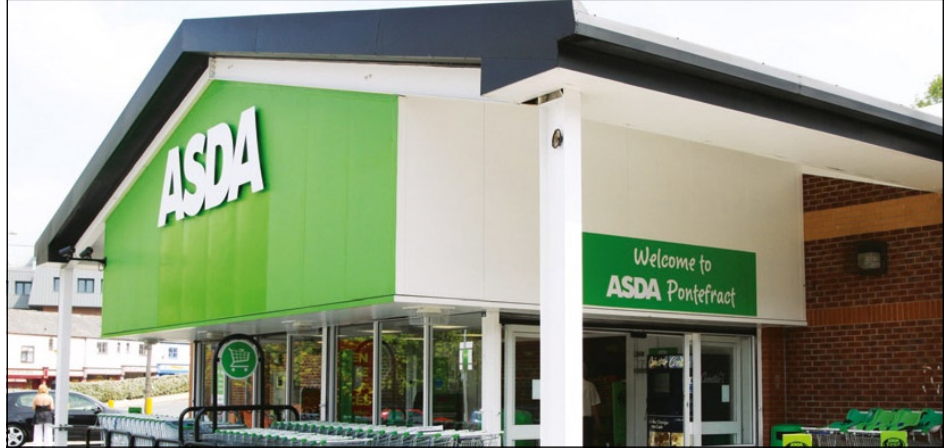
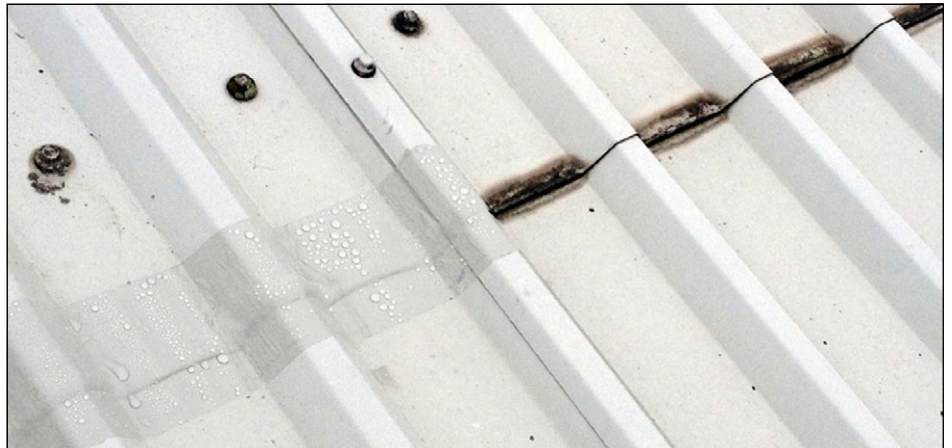
The problem was cut edge corrosion. It is caused by a combination of poor installation techniques and on-site cutting plus attack from acid rain and pollutants, which are then retained as moisture in critical roof overlaps and gutter overhangs. This results in corrosion of the profiled steel roof sheets. If not treated quickly and effectively, the damage can often lead to the need for partial or complete roof replacement. Seamsil® provides an ideal sustainable solution to the problems. It helps to extend the life of roofs treated and retain property value.

In 1994 ASDA had the foresight to use an innovative product called Seamsil®, to repair the roof of its Lutterworth Magna Park distribution centre. 20 years later its Pontefract store has become the 34th ASDA property to benefit from the patented silicone external repair system, for cut edge corrosion on profiled Plastisol/PVDF coated steel roof sheeting.
