PROJECT : Raben Group, Poznan

Delvemade Protective Coatings Programme

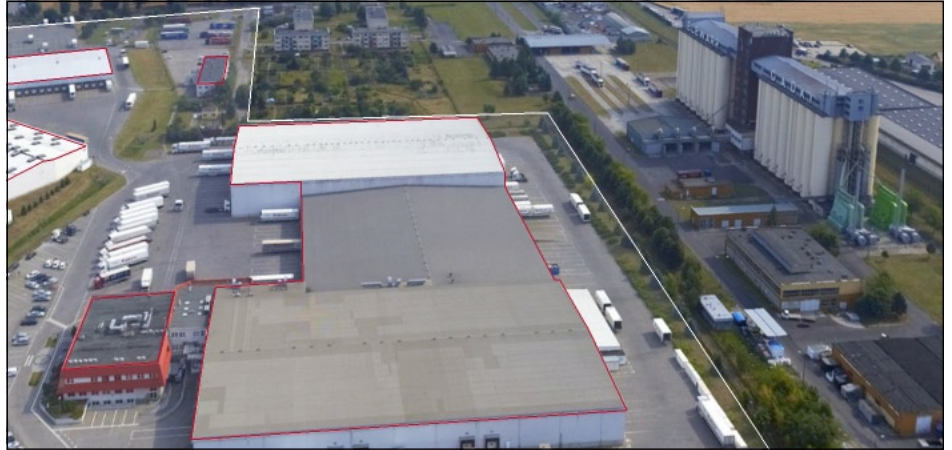
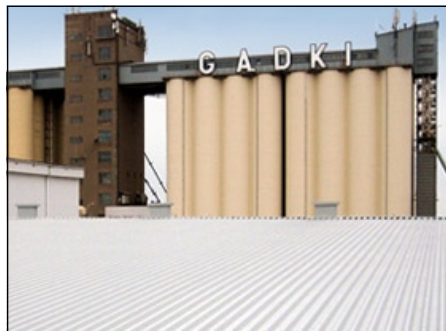
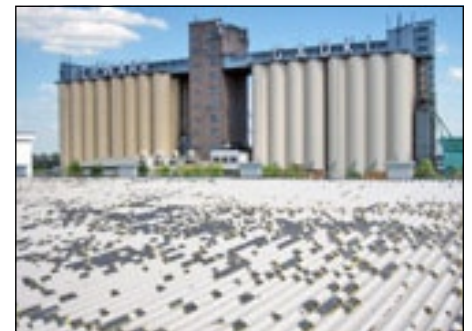
Planned refurbishment to the busy Raben Group Logistics facility at Gadki near Poznan in Poland revealed that the existing Plastisol coated steel roof sheets had reached their “re-paint decision time” and were exhibiting classic cut edge corrosion to the sheet ends together with age related delamination of the factory applied coating. The steel sheets themselves were in good condition, it was only their protective coating that needed reinstating. Since the continuous freight operation could not be disrupted, the project management team at DTZ Poland proposed recoating the roofs with Delcote[®], a silicone coating whose physical properties are proven to withstand the extremes high summer and harsh winter weather and temperature. The Delcote[®] solution was able to offer negligible site interference whilst providing complete weather protection and corrosion resistance for decades to come. Qualified applicator Kettles Ltd first treated the roof to Seamsil[®], preventing further corrosion to the critical lap joints and other areas of cut edges and fixings followed by Delcote[®] silicone coating, applied to a finish colour of Goosewing Grey.
