PROJECT : Halfords Store, Darlington

Delvemade Protective Coatings Programme

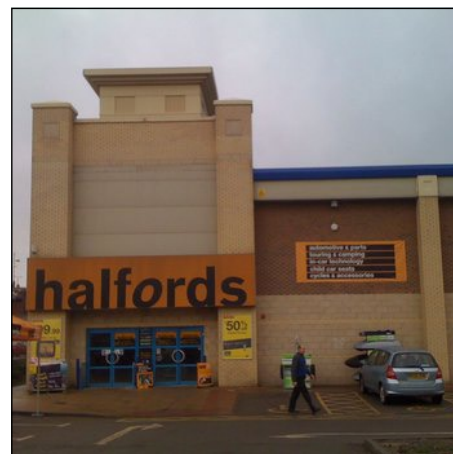
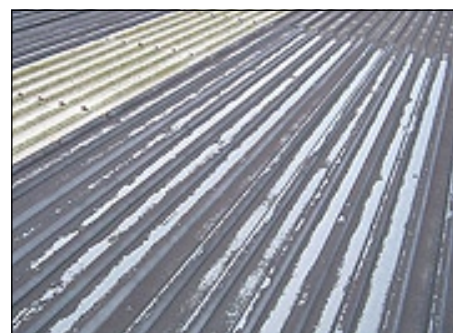
Planned refurbishment to the unit housing the busy Halfords store in Darlington revealed that the existing PVC coated steel roof sheets had reached their "re-paint decision time" and were exhibiting classic cut edge corrosion to the sheet ends and overlaps together with age related delamination of the factory applied coating. The original steel sheets themselves were in good condition. It was only the protective coating that needed replacing and since the busy store could not be closed for prolonged repairs, the project management team at CBRE chose to recoat the roof with Delcote®, a solution which offered negligible site disruption whilst providing complete weather and corrosion resistance for decades to come. Qualified applicator D. Evans Ltd first treated the roof to Seamsil®, preventing further corrosion to the critical lap joints and other areas of cut edges and fixings followed by Delcote® silicone coating, applied to a finish colour of Slate Grey.

SEAMSIL® for cut edge corrosion

DELCOTE® for roof recoating
