# PROJECT : Asda, Pontefract

The Pontefract site, is the latest ASDA store to get Seamsil® cut edge roofing treatment. In 1994 ASDA had the foresight to use an innovative product called Seamsil®, to repair the roof of its Lutterworth Magna Park distribution centre. 20 years later its Pontefract store has become the 34th ASDA property to benefit from the patented silicone external repair system, for cut edge corrosion on profiled Plastisol/PVDF coated steel roof sheeting.

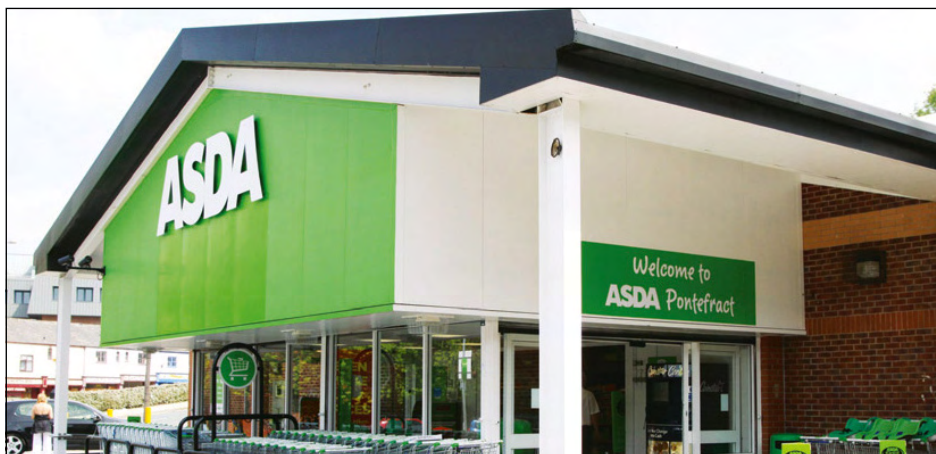
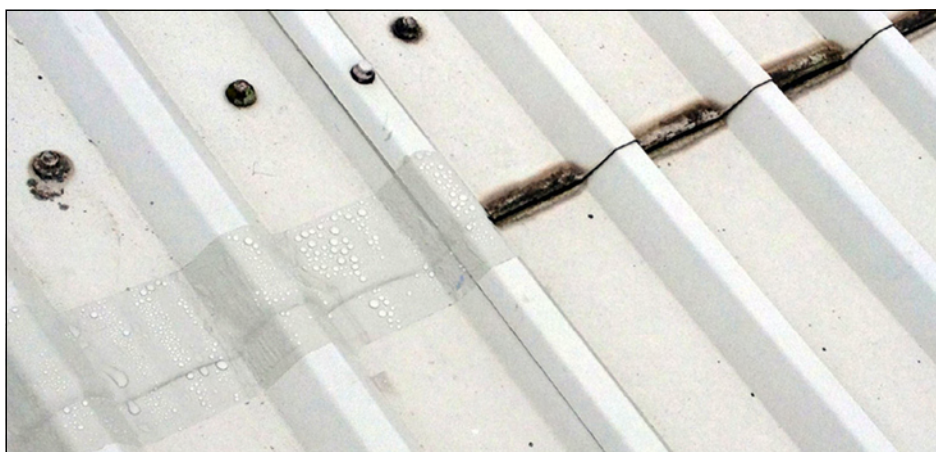
The problem was cut edge corrosion. It is caused by a combination of poor installation techniques and on-site cutting plus attack from acid rain and pollutants, which are then retained as moisture in critical roof overlaps and gutter overhangs. This results in corrosion of the

profiled steel roof sheets. If not treated quickly and effectively, the damage can often lead to the need for partial or complete roof replacement. Seamsil® provides an ideal sustainable solution to the problems. It helps to extend the life of roofs treated and retain property value.
