PROJECT : Total Fitness, Chester

Total Fitness

SEAMSIL[®] for cut edge corrosion

DELCOTE[®] for roof recoating

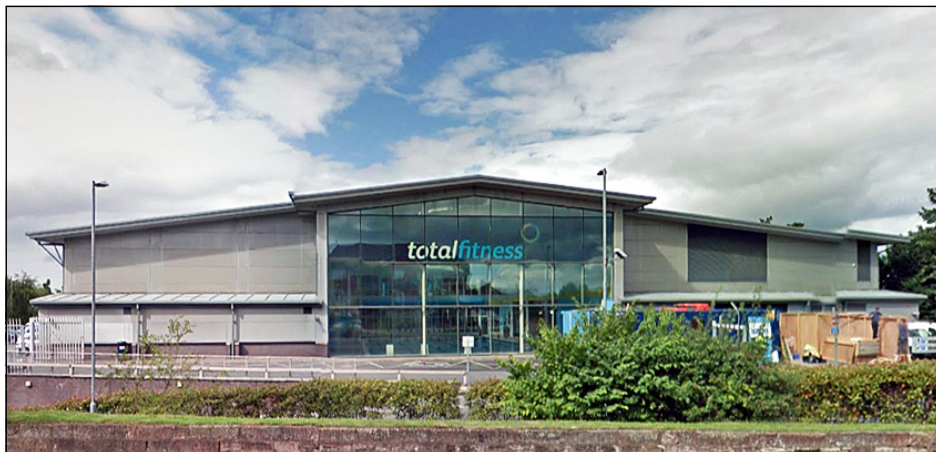
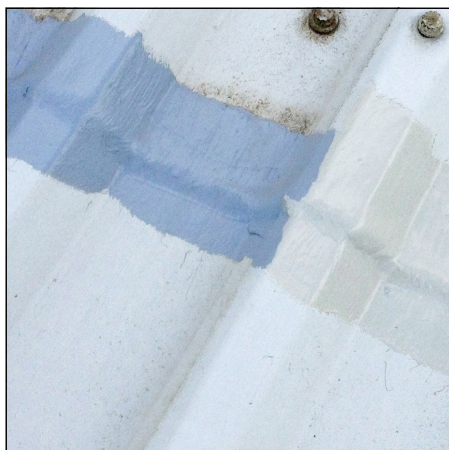
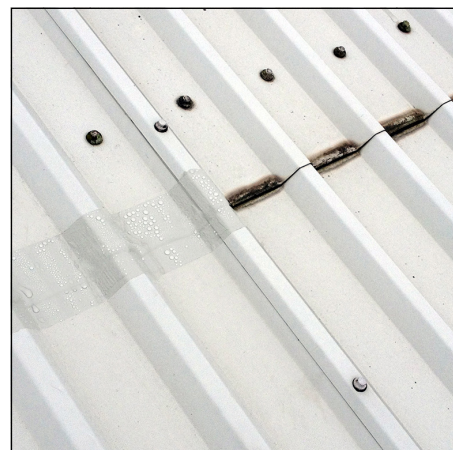
The problem was cut edge corrosion. It can be caused by a combination of poor installation techniques and on-site cutting plus attack from acid rain and pollutants, which are then retained as moisture in critical roof overlaps and gutter overhangs. This results in corrosion of the profiled steel roof sheets. If not treated quickly and effectively, the damage could lead to the need for partial or complete roof replacement.

Seamsil[®] has been specified and used to secure the long term performance of the roof at the Chester Total Fitness Centre with a roof makeover with Seamsil[®] the UK's leading Cut Edge Corrosion Treatment.

During the last 3 years, seventeen of the famous physical fitness centres have benefitted from the application of Seamsil[®], part of a time proven remedial system for the external repair of profiled steel roof sheeting.
